Impact of Water Source Depletion on Livelihood: Linkage with Chure–Kang River Basin

Abstract:

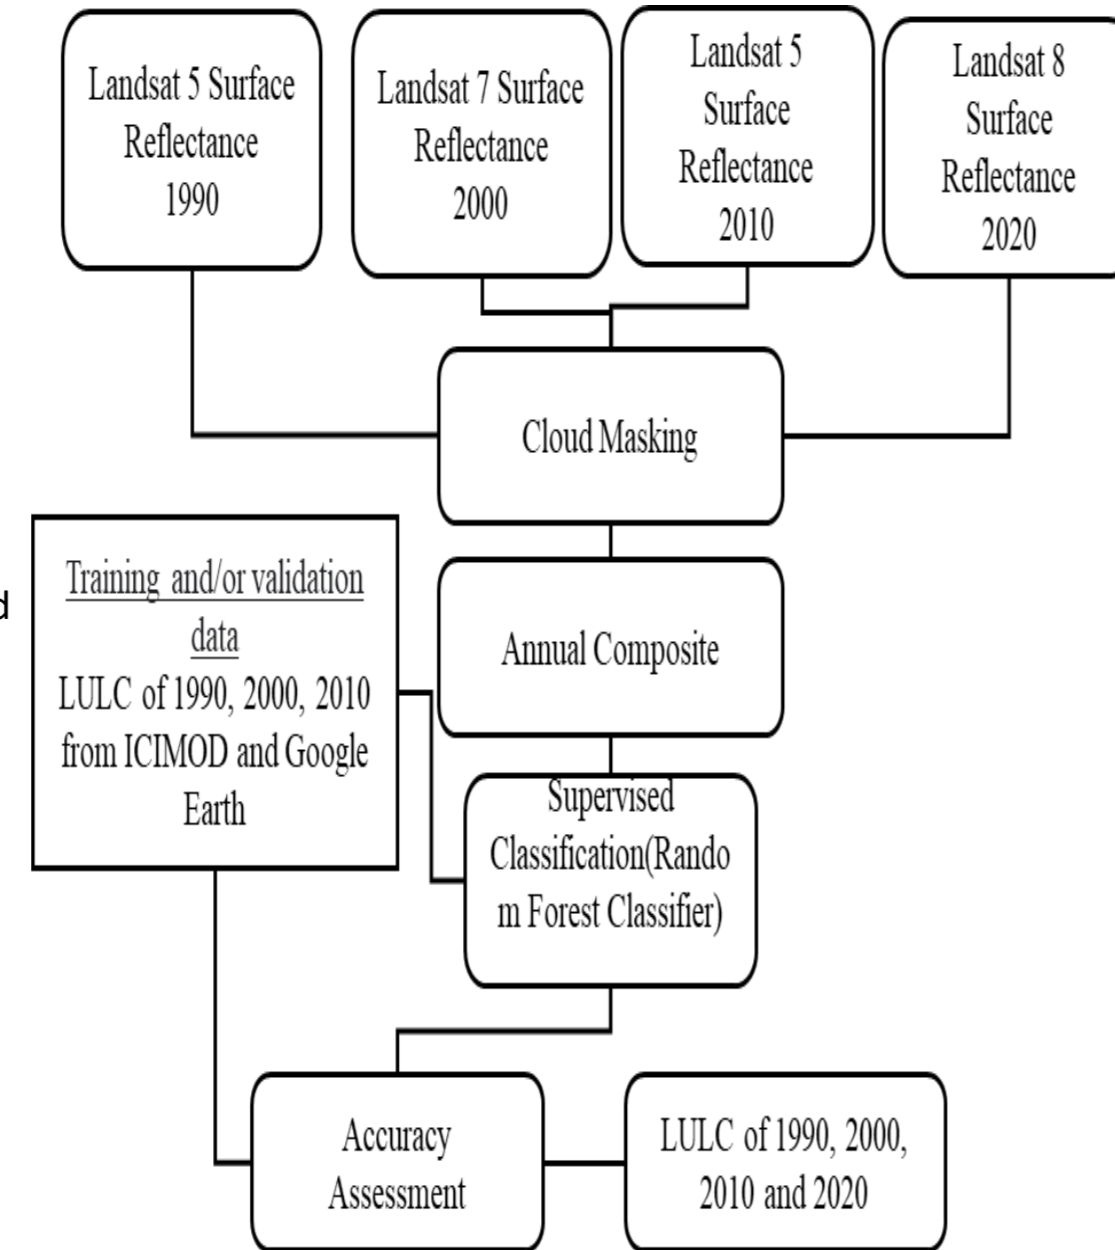
Fig.2: Flow chart summarizing the process for modeling the land use land cover change in Kang River Basin

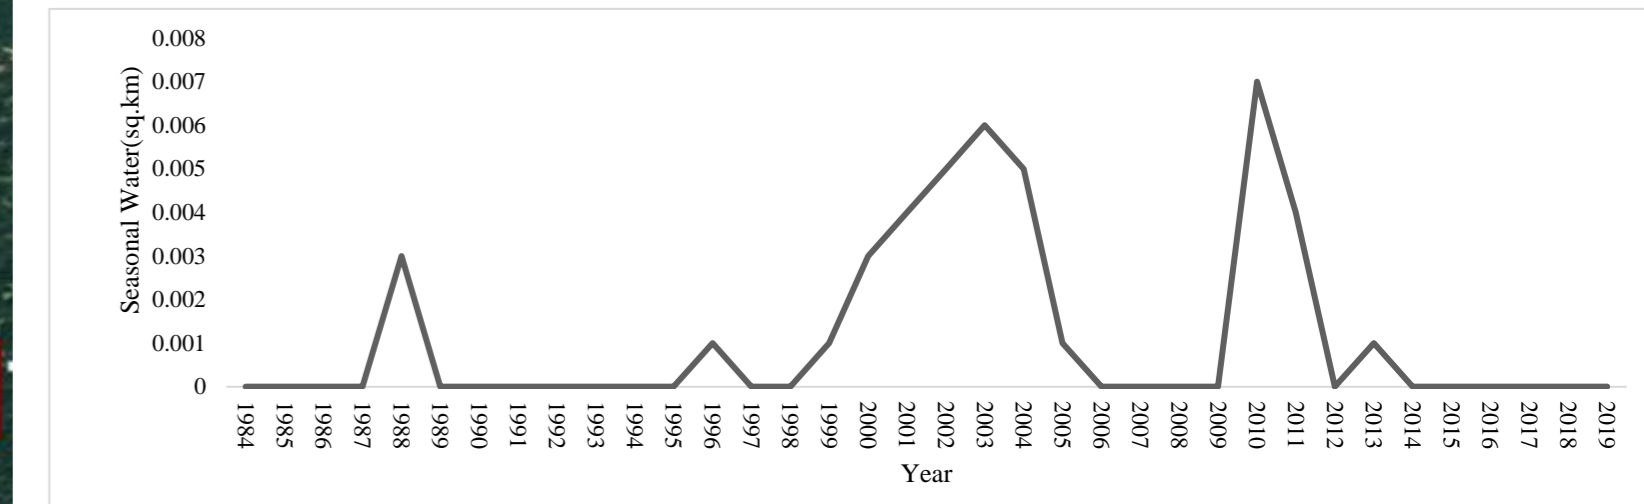
Fig.5: An illustration showing trend of extent (Sq. Km) of Seasonal Water in Kang Watershed

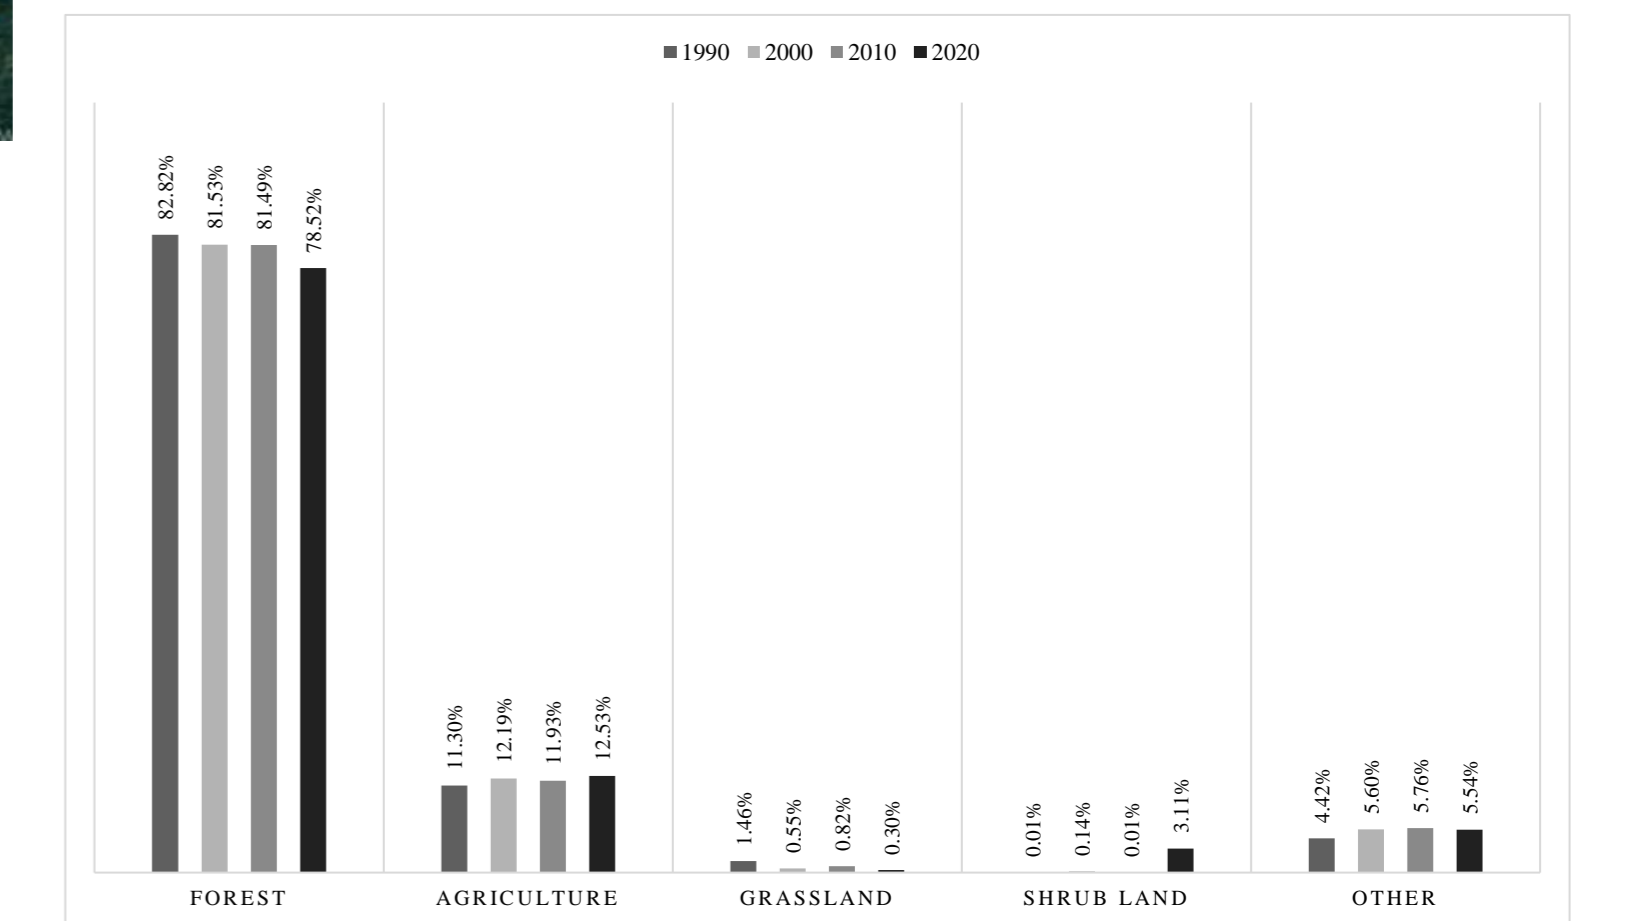
Fig.8: Bar graph showing temporal LULC of Kang Watershed.

•We found that out of 9 recharging spring sources 3 were active and others were dry.
 •The forest cover was found decreasing by 4.3% in last 30 years (1990-2020).
 •38.0% of people are facing the problem of quality drinking water which made their living difficult.

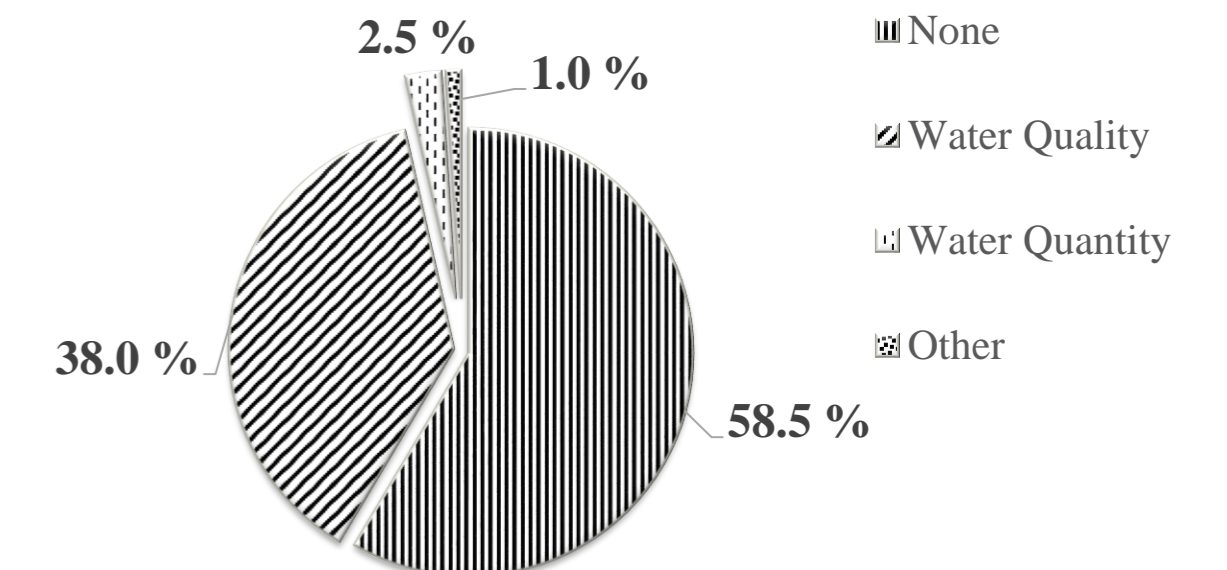
Fig.10: Difficulties mostly faced in drinking water
