# Vulnerability of urban freshwater lakes to emerging pollutants in Colombo, Sri Lanka

M. D. K. L. Gunathilaka<sup>1&2</sup>, M.W. R. Nuwanka<sup>3</sup>

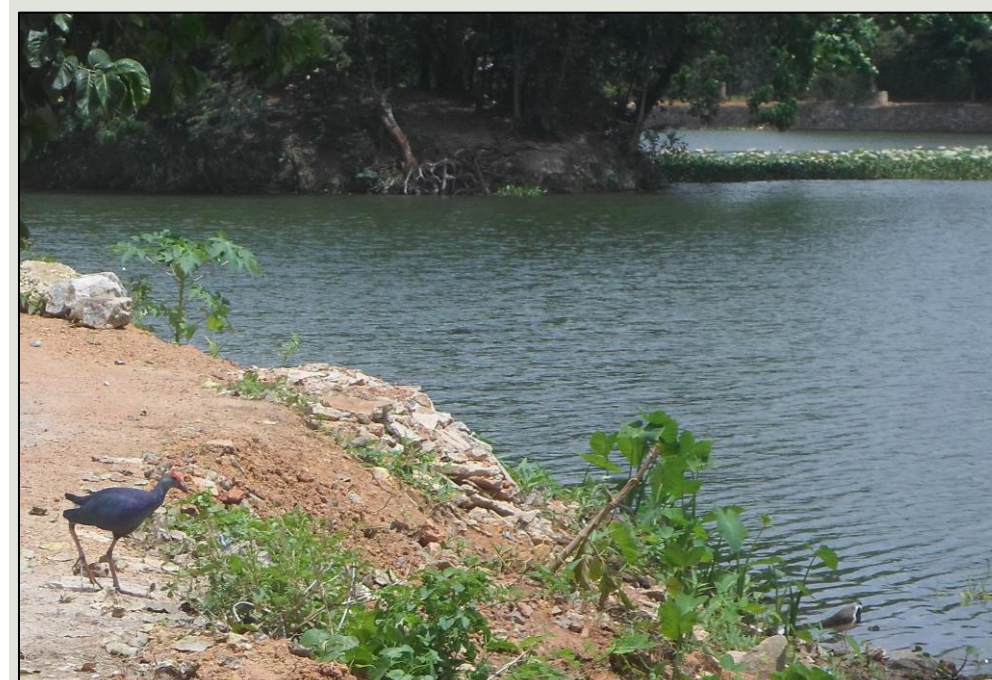
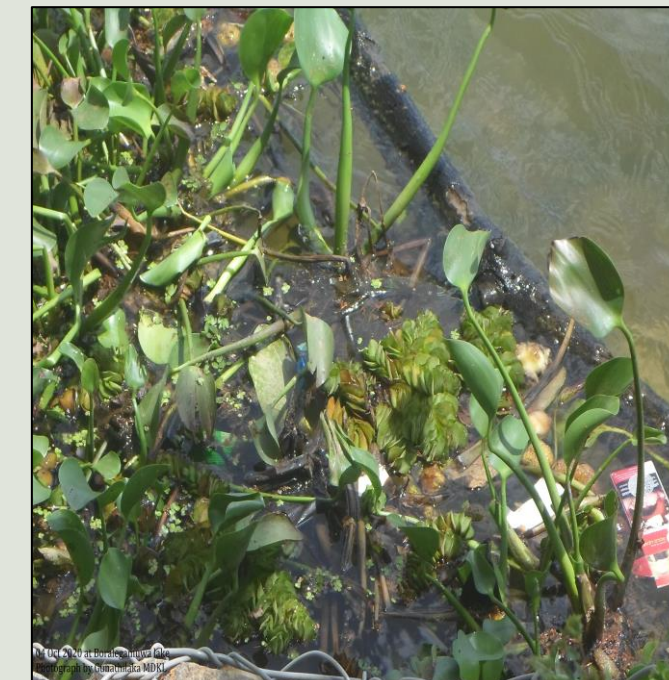
- Invasion of water hyacinth, scattered Salvinia mats, Kankun (*Ipomoea aquatica*) along with the bunt, and various weeds spread over the slope of the bunt. Scattered *Colocasia esculenta*, *Marsilea quadrifolia* over the water body, and Nil monaressa (*Utricularia reticulata*) (rarely) under the water body are visible making the scenery less attractive.

- Drainage pipes from the town end at the lake provide considerable sludge while household waste and wastewater are also released to the lake.
- The industrial effluents and additional waste from recreational activities already maximize the environmental issues of the lake.

- The spread of plastic waste and alcohol cans is observable.
- Unauthorized settlers and encroachments were identified since 2000.
- High coliform fecal coliform counts were reported.
